Manhole Inspection Summary

Manhole # S19M__038MH

Insp Date: **3/31/08 9:03 AM**

Location Address: **2230 christian st**

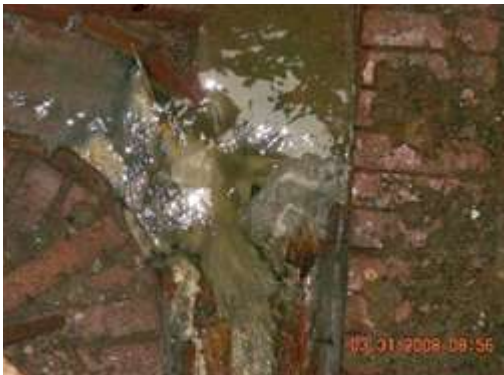
Defect 3

Condition: ☐ Sound ☐ Cracked ☐ Root Intrusion ☐ Deteriorated ☐ Leaks ☒ **Debris**

debris in channel

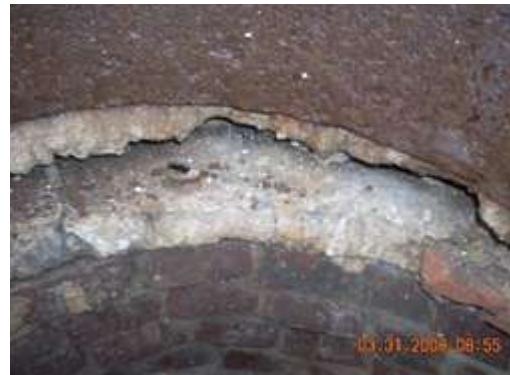
Defect 2

Condition: ☐ Sound ☐ Cracked ☐ Root Intrusion ☐ Loose Brick ☒ **Deteriorated**

deteriorated chimney

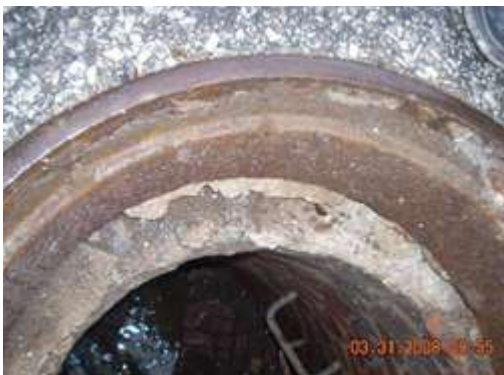
Defect 1

Offset: **4** (in.)

frame offset

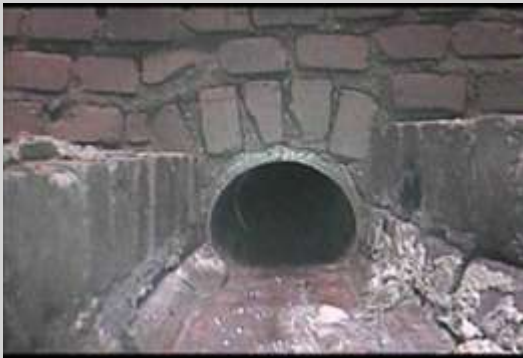
12 O'Clock Outflow

Pipe Height: **7.2** (in.) Rod and Bar (Angled)
Pipe Material: **Clay** ☐ Pipe Lined
Invert Depth: **7.31** (ft.) Flow Characteristics: **Slow**
Deposits: ☒ None ☐ Mud ☐ Sludge ☐ Debris ☐ Grease
Silt Depth: **0** (in.) Deposits Extent:
Infiltration: **None** Pipe Seal Cond: **Sound**

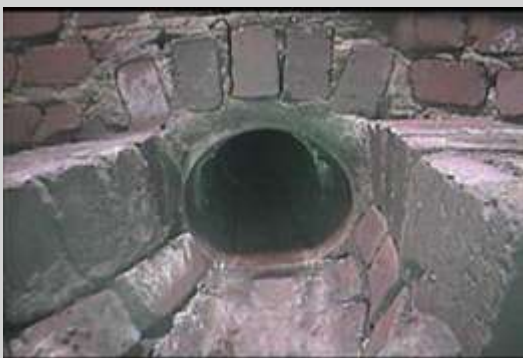
3 O'Clock Inflow

Pipe Height: **8.4** (in.) Rod and Bar (Angled)
Pipe Material: **Clay** ☐ Pipe Lined
Invert Depth: **6.94** (ft.) Flow Characteristics: **Slow**
Deposits: ☒ None ☐ Mud ☐ Sludge ☐ Debris ☐ Grease
Silt Depth: **0** (in.) Deposits Extent:
Infiltration: **None** Pipe Seal Cond: **Sound**

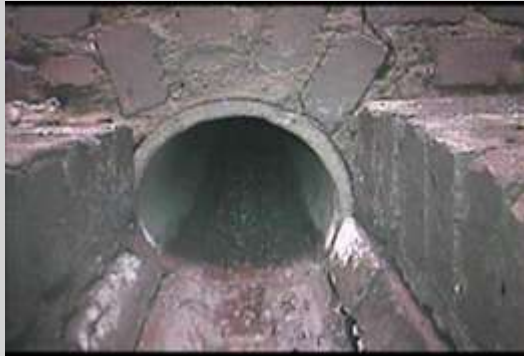
6 O'Clock Inflow

Infiltration: **None** Pipe Seal Cond: **Sound**
